Parish Flood Report: Burford

July 2008

This document is the Parish Flood Report for Burford and has been prepared by the Council's Engineering team. It pulls together information from external agencies and individual property owners and seeks to identify the causes of flooding in Burford during July 2007 and potential mitigating solutions.

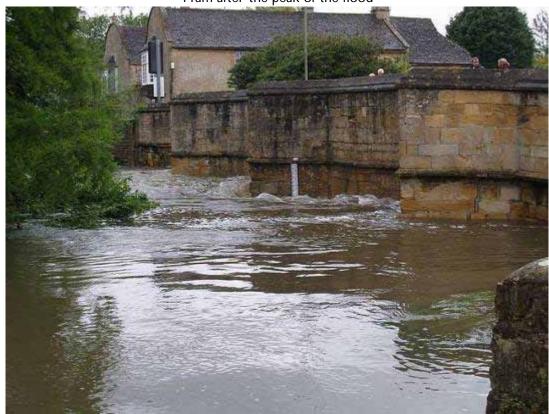
In 2007 the properties in this area experienced flooding from the River Windrush. It is believed that the flooding was caused by the capacity of the Burford Bridge becoming exceeded, thus causing water to back up and spill into the properties. Observations made during the event suggest that the water within the properties was approximately 0.5m deep. In addition, flood water was observed to be at approximately 101.3mAOD at the bridge on the day of the flood (albeit this level was recorded at 11am, some 5 hours after the 5am peak flow). The typical water level at the bridge is approximately 100.6mAOD. Photographs showing these can be seen in Appendix 1.

Photo1 Surcharging Burford Bridge taken from land adjacent to Island House (Area 1). This was taken at 11am after the peak of the flood

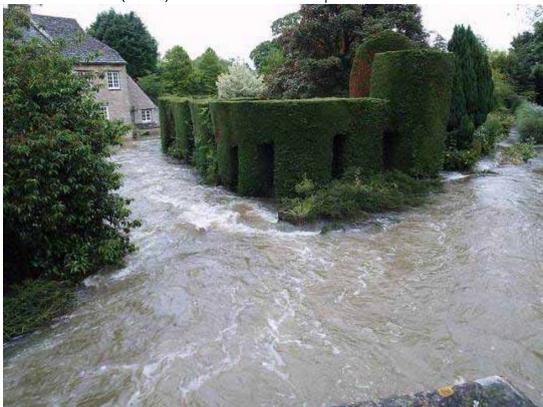
Photo2 River Windrush downstream of Buford Bridge, northern channel to left and Mill Race to the right (Area 2). Taken at 11am after the peak of the flood

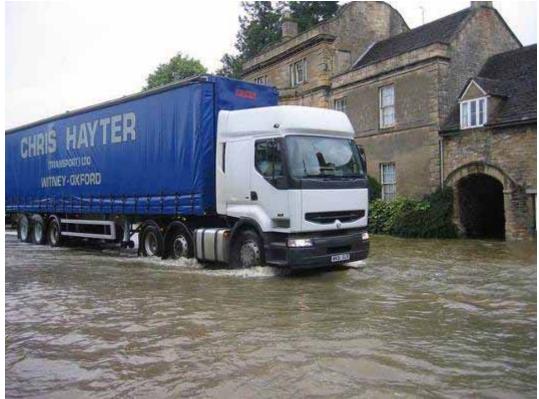
Burford Flood Defence Report July 2008 Photo3 Lorry driving down A361, towards Burford Bridge (Area 3) through floodwater, looking southwest. Photograph taken at 11am after the peak of the flood

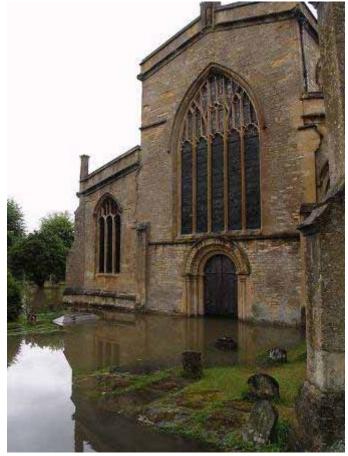
Flood water continued along Lawrence lane and into the church and graveyard. It is believed that the graveyard was only inundated from water flowing from Lawrence lane and not from overtopping in the Mill Race. It was noted however that the small banks located along Mill Race needed to be raised in local low spots with sandbags and reinforced in other areas where leaking was noticed.

Photo4 St John the Baptist's Church, looking west from entrance to Lawrence Lane (Area 3)

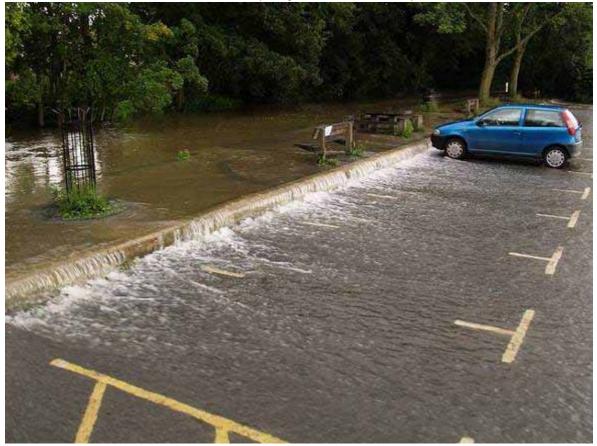
Although no properties are located within the vicinity of the car park, it experienced flooding during 2007 and is known to experience flooding more regularly than other areas within the Burford. Flooding occurs at this location when the levels in the Mill Race rise above the surrounding ground. During the site visit, a small outlet control was seen to be present downstream of the car park that enabled flows to leave the Mill Race and enter the 'natural' channel to the north. However, it was observed during the site walkover that the outlet control has become partially blocked and therefore not functioning to its design capacity.

Photo5 River Windrush spilling at Guildenford car park (Area 4)

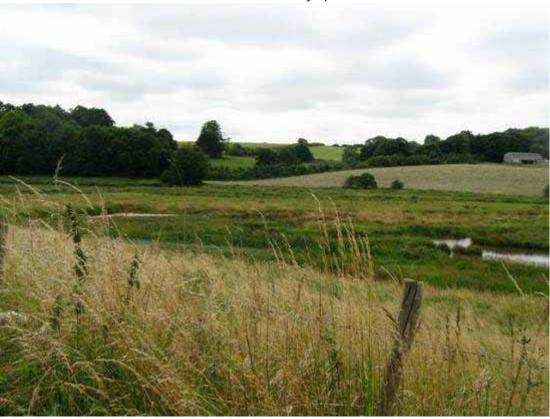
Photo6 River Windrush and valley upstream of Burford

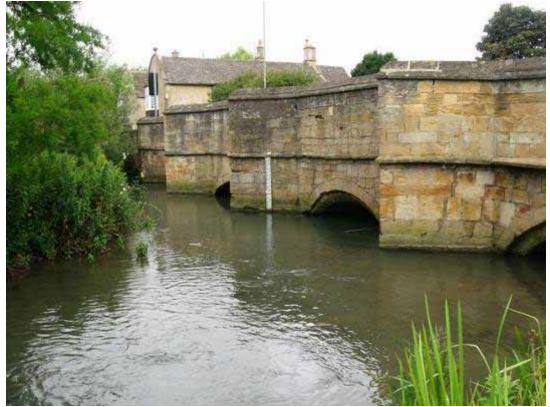
Photo7 Burford Bridge taken from Island House (Area 1)

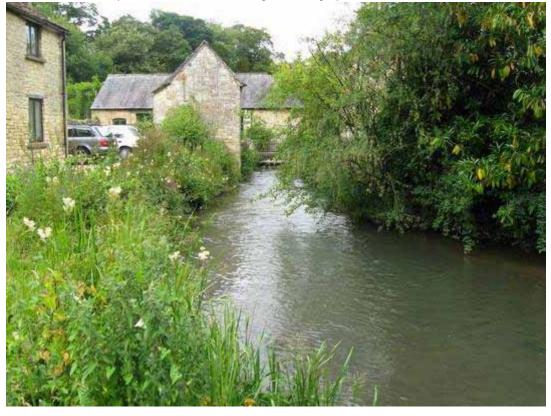
Photo8 River Windrush upstream of Burford Bridge, looking upstream (west). Island House is on the left

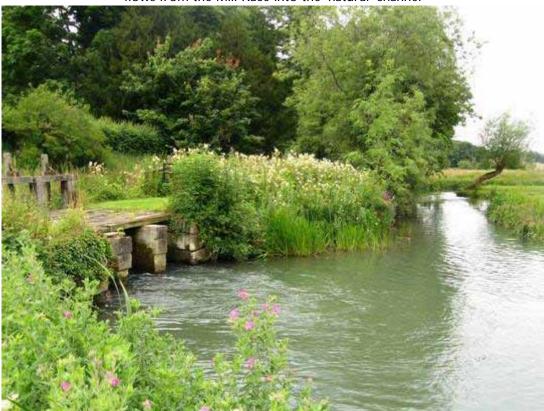
Photo9 River Windrush upstream of Burford Bridge, looking upstream (west) at sluice gate controlling flows from the Mill Race into the 'natural' channel

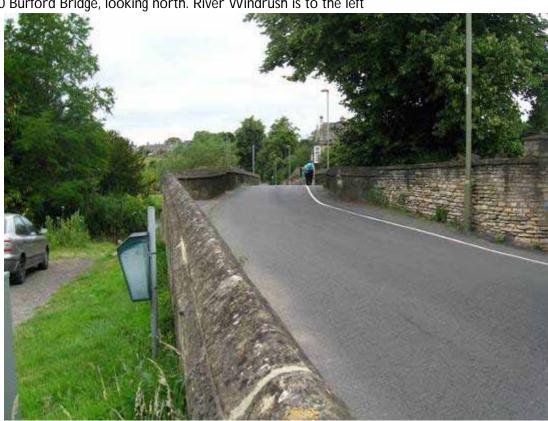
Photo10 Burford Bridge, looking north. River Windrush is to the left

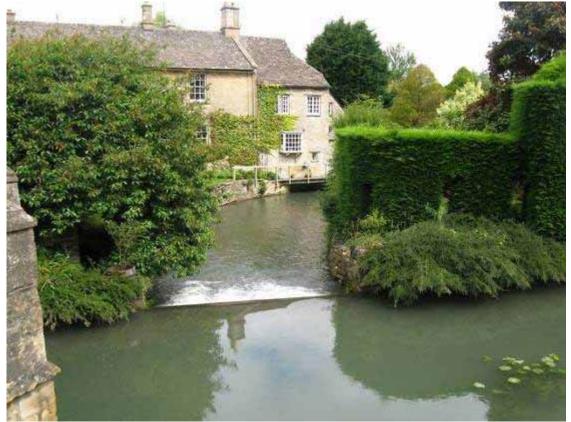
Photo11 View towards properties adjacent to northern channel, downstream of Burford Bridge (Area 2). Weir controlling flows shown in foreground

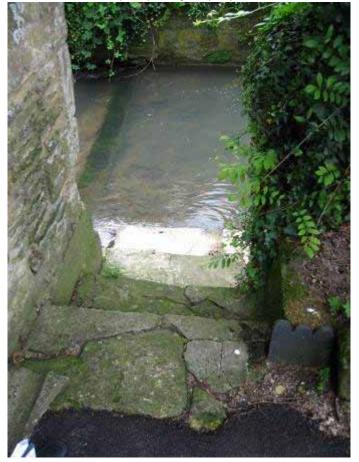
Photo 12 Example spillway to properties in Area 2

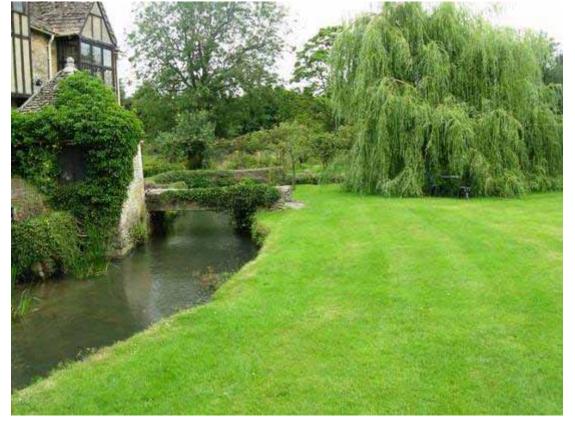
Photo 13 River Windrush (northern channel) and property in Area 2 looking downstream (east)

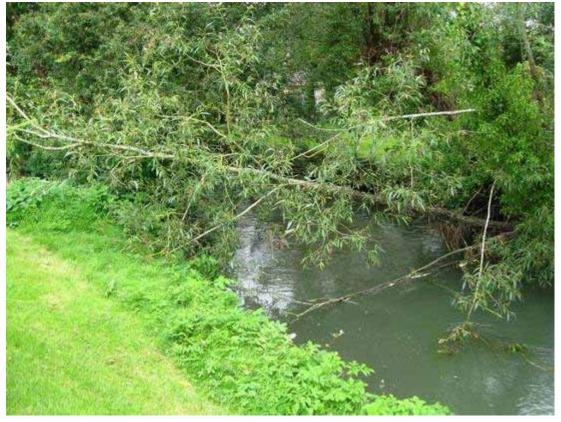
Photo 14 Fallen trees in River Windrush (northern channel) in Area 2

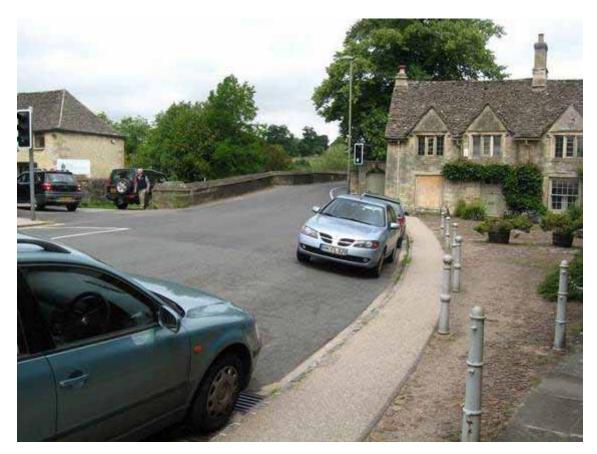
This area predominantly experienced flooding due to water surcharging Burford Bridge and migrating to the south, thus flooding the low lying areas located immediately east of the bridge. Due to the depth of water and the nature of the topography, floodwater flowed up to and along (to the east) Lawrence Lane (i.e. approximately following the line of the Environment Agency's Flood Zone 2). It is worth noting that the floor levels of the properties in this location are lower than the surrounding ground, thus providing a flow path for water.

Photo 15 Topography of land sloping towards property to south of Burford Bridge, looking west towards Burford Bridge and River Windrush (Area 3)

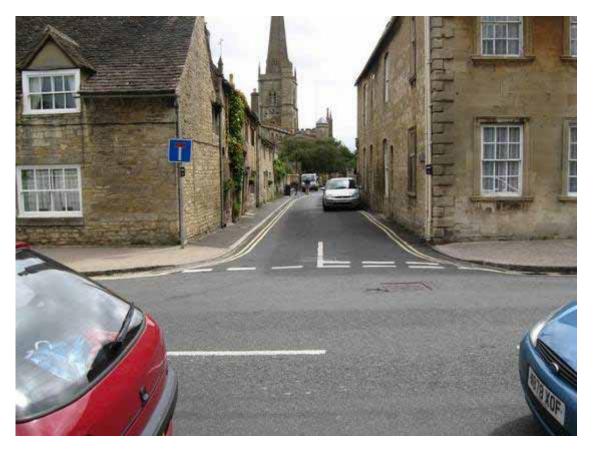
Photo 16 View along Lawrence Lane towards the church from High Street (A361), looking east (Area 3)

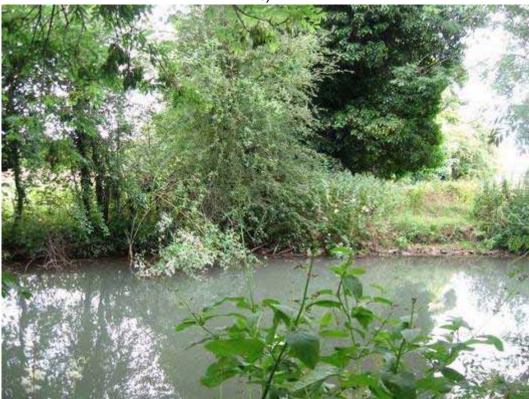
Photo 17 Former weir from watercourse (Mill Race) into the northern channel, adjacent to church (Area 3)

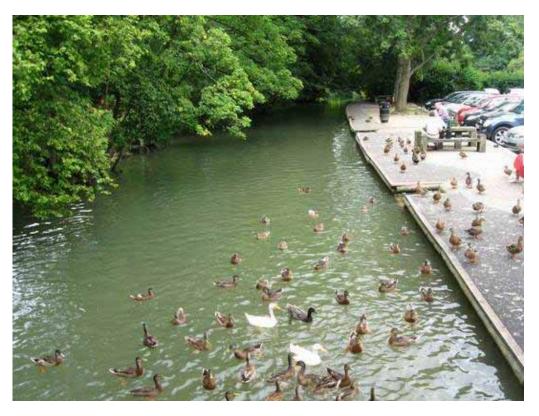
Photo18 River Windrush (Mill Race) from bridge to car park (Area 4), looking upstream (west)

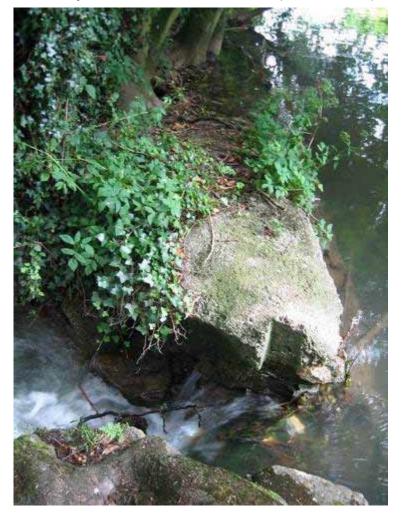
Photo19 Outlet from Mill Race taking flow into the northern channel upstream of car park (Area 4)
