Parish Flood Report: **Black Bourton**

July 2008

This document is the Parish Flood Report for Black Bourton and has been prepared by the Council's Engineering team. It pulls together information from external agencies and individual property owners and seeks to identify the causes of flooding in Black Bourton during July 2007 and potential mitigating solutions.

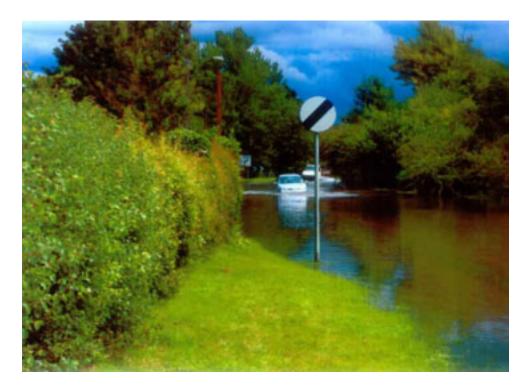
Photo I - Flooding on Station Road above the village green July 2007

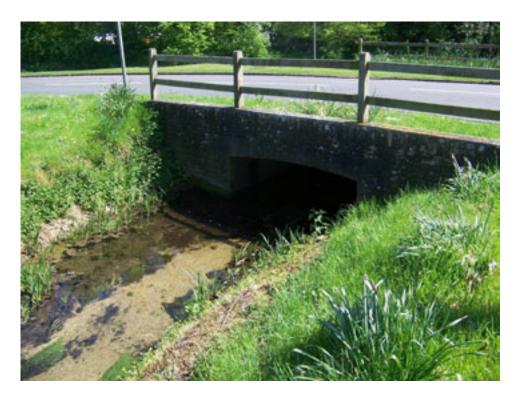
5.2.1 Inadequate capacity of the bridge at Station Road/Burford Road junction (see photo 2)

The capacity of the bridge opening was not sufficient to take the peak runoff flow in the Black Bourton Brook in July 2007. Water levels rose significantly in a short period of time causing backing up of water along the Black Bourton Brook and flooding of property.

Photo 2 – Station Road Bridge at village green

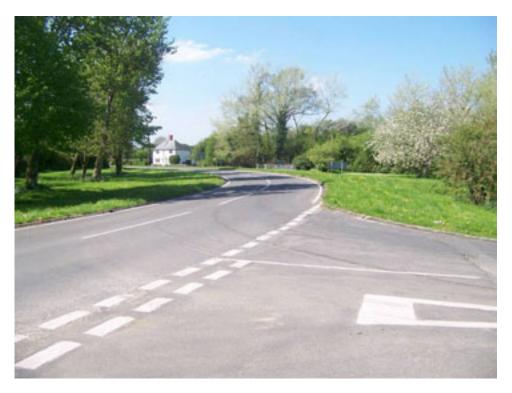
Photo 3 - Junction with Station Road - village green on right, looking towards Alvescot

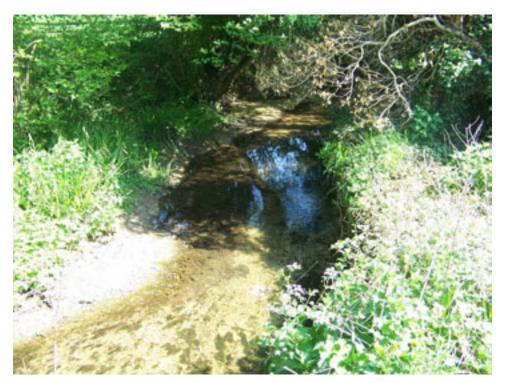
5.2.2 Inadequate capacity of the Black Bourton Brook downstream of Station Road Bridge (see photo 4 and 5)

A site visit highlighted that the capacity of the Black Bourton Brook upstream of the road bridge is larger than that of the engineered channel downstream. Local residents believe that this led to backing up of the watercourse and prevented drainage of surface water away from the village.

Photo 4 - Black Bourton Brook looking upstream from Station Road towards Glebe Farm

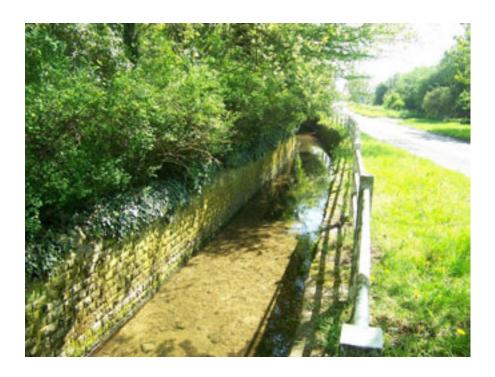
Photo 5 - Black Bourton Brook – looking downstream from Station Road Bridge. Channel capacity smaller than upstream of the bridge (Photo 4)

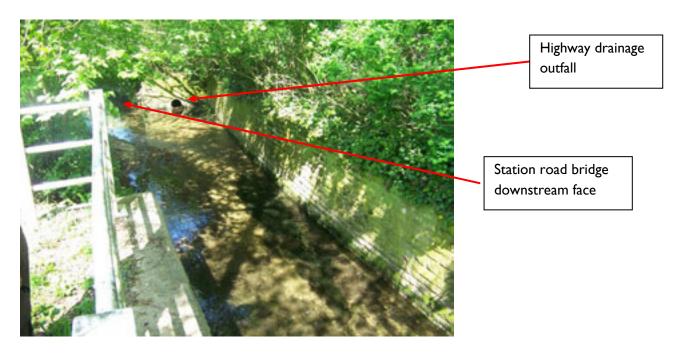
Local residents confirmed that surface water and highway runoff was running straight down the Burford Road during July 2007. The outfall for the highway drainage is a small pipe to the Black Bourton Brook which due to its low level becomes submerged when the water level rises in the Brook.

The low invert level of the outfall into Black Bourton Brook may well have allowed flood water from the watercourse to 'back up' through the highway drainage system to inundate the Burford Road at the junction with Station Road. In addition to this, water would not have been able to drain away.

Photo 6 - Black Bourton Brook - Station Road Bridge to left, highway drainage outfall at bed level in right.

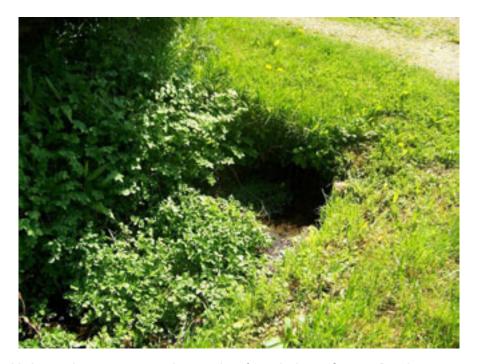
5.2.4 Inadequate drainage on Burford Road (see photo 7)

The drainage provision on Burford Road consists of a ditch on the southern side of the road at Model Cottages. The ditch appeared to be poorly maintained on inspection in May 2008. The ditch enters a small culvert which outfalls to the Black Bourton Brook. Ownership of this ditch needs to be confirmed with OCC to allow the necessary works in Section 6.0 to be carried out.

Photo 7 - Highway drainage on southern side of road above Station Road junction near Model Cottages. Channel was overgrown on inspection in May 2008.

- Option B & G - EA to improve maintenance of Black Bourton Brook and Shill Brook to include downstream reaches. EA have recently cleared vegetation on the Black Bourton Brook at the village triangle (June 2008).
- **Option H** OCC to improve maintenance of existing highway drainage system to include a survey of pipe condition, blockages and ditch condition.

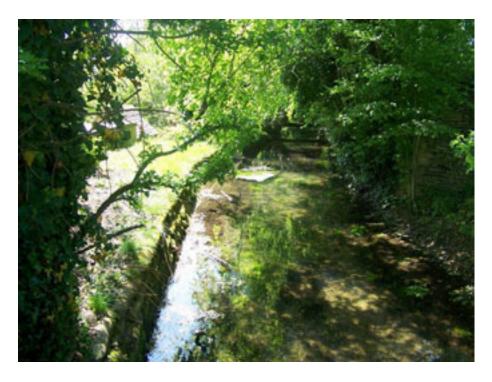
Photo 8 - Shill Brook through village — looking upstream from footbridge near to village green

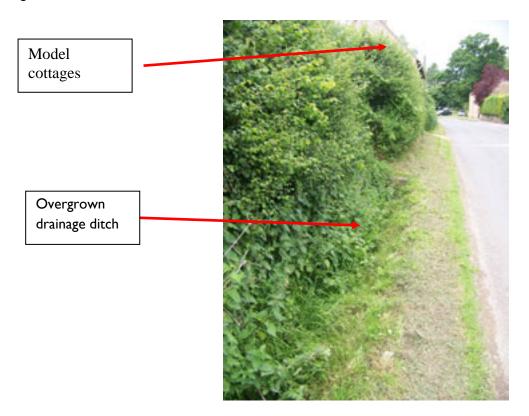
Photo 10 - Highway drainage at Model Cottages
