# Parish Flood Report: Milton Under Wychwood

May 2008

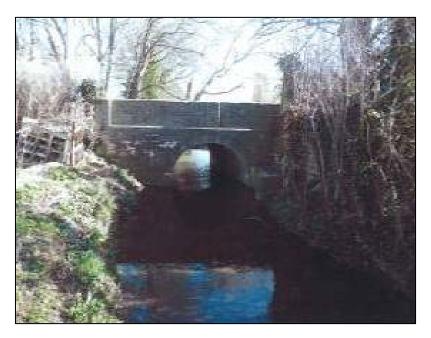
**Area I – The Heath**Church Road Bridge, looking downstream along Little Stock Brook

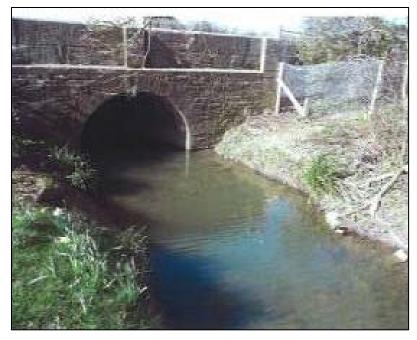
**Area I – The Heath**Church Road Bridge, looking upstream along Little Stock Brook

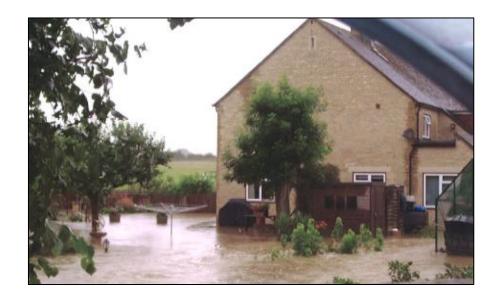
Area I - The Heath

July 2007 flood, looking upstream from Church Road Bridge to properties at the Heath

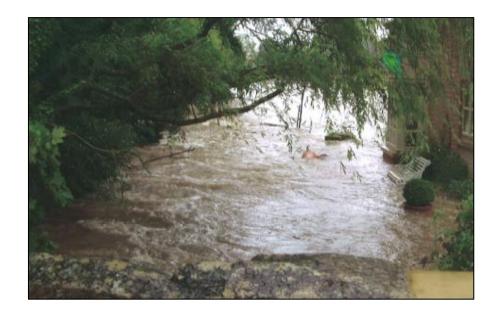
**Area I – The Heath**July 2007, looking downstream from Church Road Bridge along Little Stock Brook

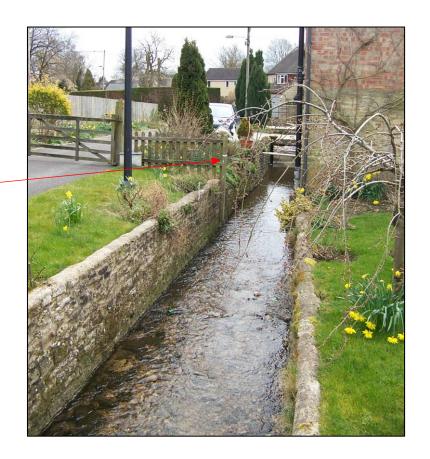
# **Area I – The Heath**Little Stock Brook running in front of properties

White mark shows height of flood water July 2007

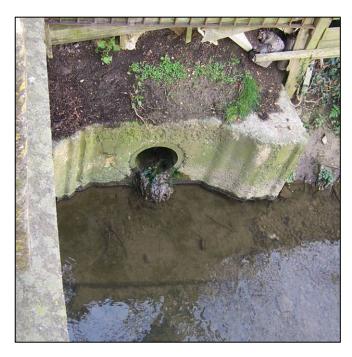
**Area I - The Heath**Road drainage outfall from Church Meadow

- Option B OCC to remove existing highway drainage outfall to Little Stock Brook and replace it out falling downstream of the bridge.
- Option F Flood resilient measures on properties in the 1% (1 in 100 year) Flood Zone

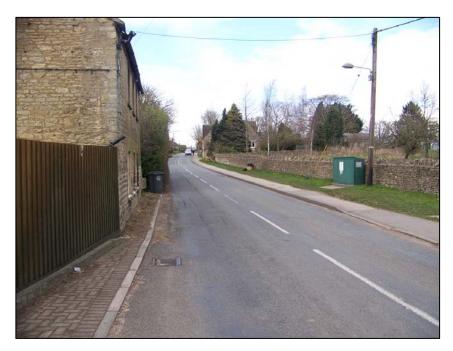
# Area 2 - The Old Mill

The Thames Water pumping station located opposite Mill Cottage on the Shipton road is unable to cope with peak volumes of surface water arriving from the village combined sewers during peak storm periods. This has led to foul flooding across the Shilton Road.

Looking towards Milton along the Shipton Road, showing location of the Old Mill and Thames Water pumping station

- OCC to carry out a CCTV survey of highway drainage at the Mill to establish its condition. (Option A) and re-design if required (Option C)
- Thames Water to carry out an assessment of the capacity of the pumping station and increase capacity if required (Option E).

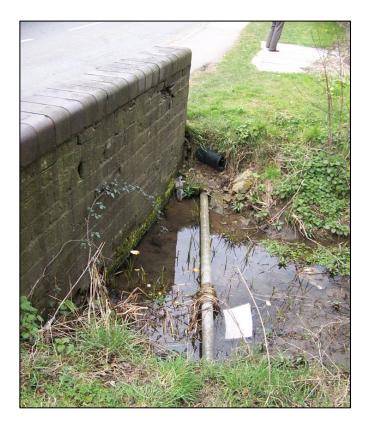
Road runoff discharges to the old mill watercourse which is heavily overgrown and silted up.

Area 2 - The Old Mill
Road Drainage outfalls to blocked ditch

D	Maintenance of watercourse that is located on the northern side of the Shipton Road, on the downstream side of Old Mill Cottage.	Potential land drainage consent required.  Consult EA on ecology and potential for presence of contaminated silt which would require a waste licence.			ordination role.  WODC to examine powers under the Land Drainage Act	out and de-vegetated at least to the point where the two	road drainage to work more efficiently as will	This will not cause or exacerbate flooding in other areas.	Up to £5k	Riparian owner has not been approached.
	Cause 2 – Failure of Thames Water Pumping Station  Storm water runoff from properties in Milton Under Wychwood are connected to the pumping station on the northern side of the Shipton Road at the Old Mill. During times of flood the pumping station fails causing flooding of foul water of the Shilton road and The Old mill.									
E	An assessment of the Thames Water pumping station needs to be made			Thames Water to complete an assessment of the pumping station and up-sizing where required.	WODC to provide a co- ordination role.		This scheme should totally remove risk of foul sewage flooding the road and the Old Mill.	This will not cause or exacerbate flooding in other areas.	Thames Water to provide 100% funding £5k to £20k

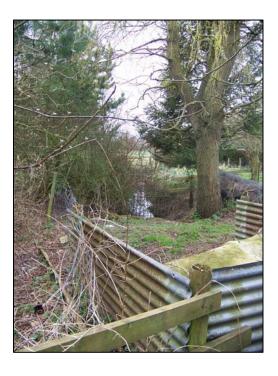
# Area 2 - The Old Mill

View along the overgrown ditch that receives water from the highways and the upstream culvert running under the Old Mill.

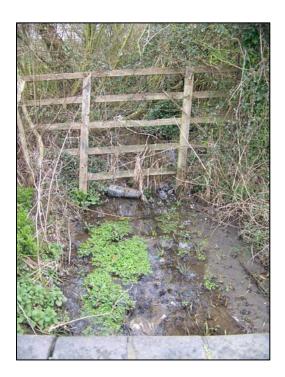
# Area 2 - the Old Mill

The property was historically used as a water mill and is located in a natural low point in the catchment. Even through the mill run has been culverted, the property is located in a natural flow path and is affected by overland flow from the rear of the property.

Looking away from the rear of the Old Mill, open water can be seen to enter a culvert but there is no obvious outfall.

Cause 3 - Overland flow from rear of property								
	The property forms a barrier to the natural flow path of overland flow.								
F	Re-create a mill pool upstream of the property where it originally was to act as storage during times of heavy rain.  Replace existing culvert under garden with a culvert of larger capacity or open the culvert up. The culvert under the road needs to be investigated and cleared.  The new culvert will connect to the newly cleared ditch.	The potential for OCC to provide part funding should be investigated as this works may reduce the strain on highway drains as overland flow will be reduced	The potential for TW to provide funding should be investigated as works will reduce overland flow and resulting flow to the pumping station. This may ease capacity problems.	WODC to provide a co- ordination role	Funding to be provided by landowner	Works will help to prevent flooding to the Mill and road and could potentially reduce loading on the TW pumping station	Adjacent field required to construct mill pool. This will not cause or exacerbate flooding in other areas.	£5k to £20k	Landowners in the upstream catchment have not been approached. Land negotiations and compensation would greatly increase cost.
