WEST OXFORDSHIRE
DISTRICT COUNCIL

Parish Flood Report: **Kelmscott**

July 2008

Appendix I: Photographs

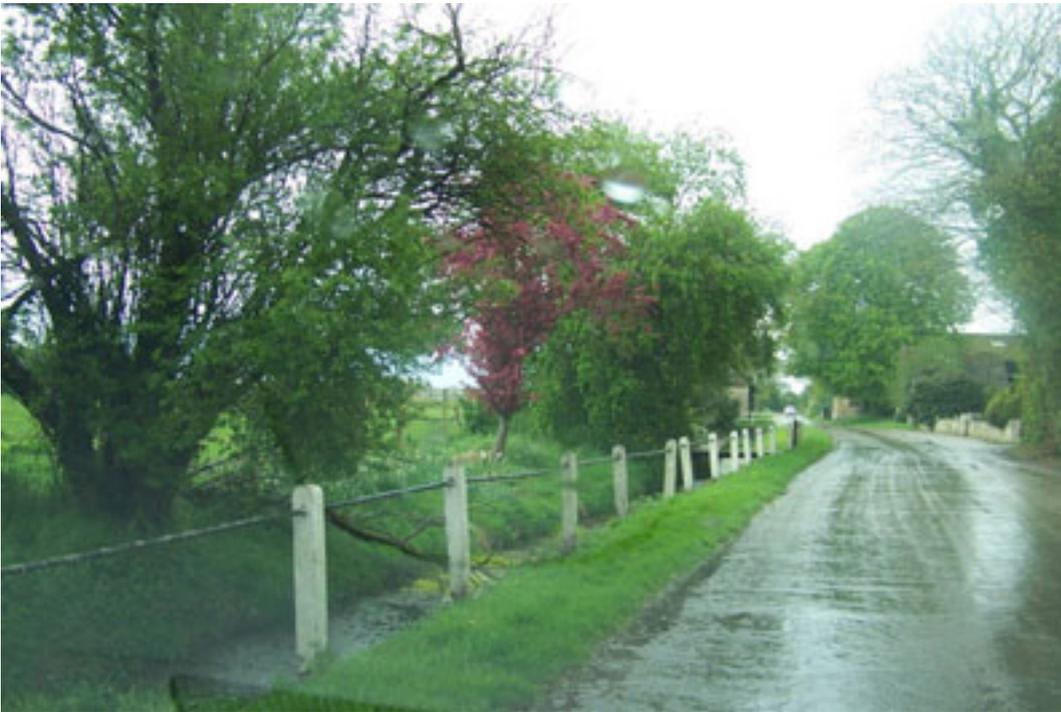
Kelmscott - College drain on right of top road. Looking west towards Lechlade

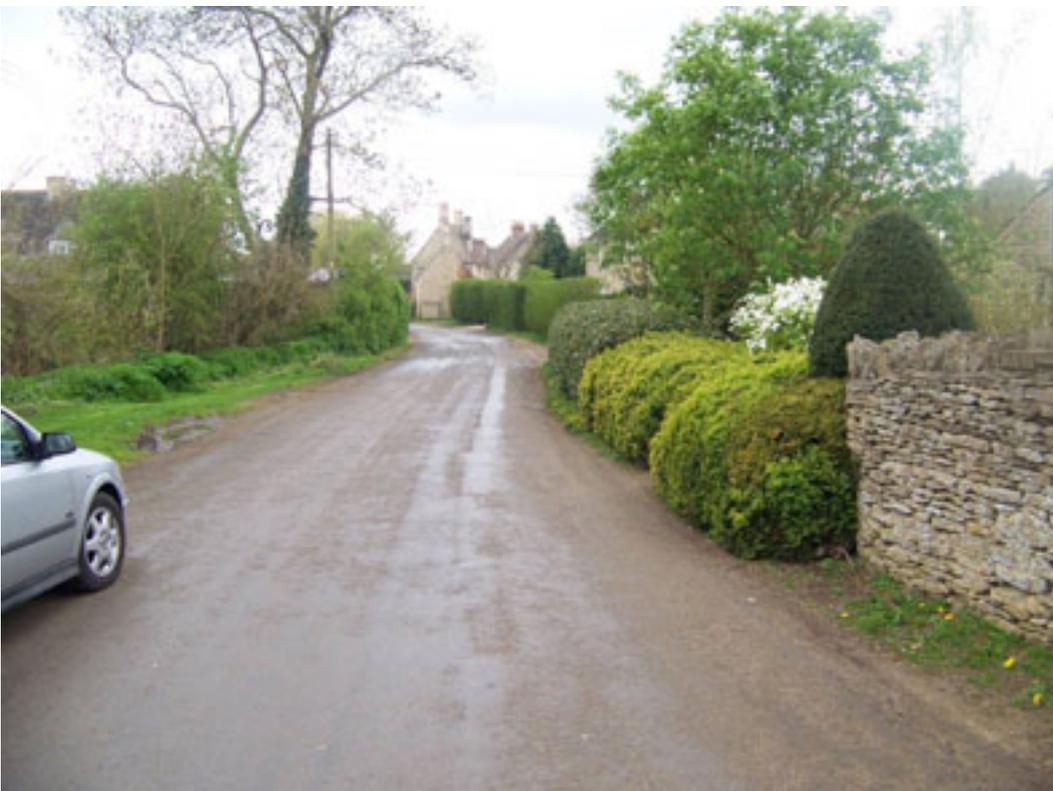
Flow route of floodwater down top road. Looking west near Old School

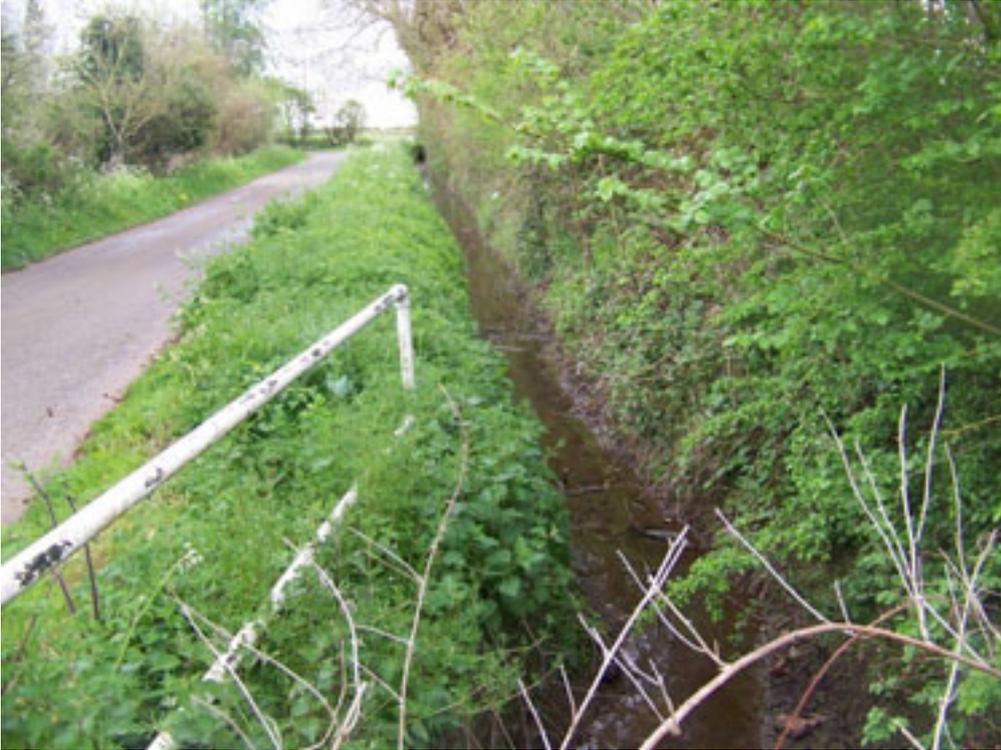
College Ditch running through the village itself is narrow, shallow, modified for aesthetic appearance and is culverted in sections. This all reduces an already small watercourse's flow capacity further, resulting in large volumes of water flooding onto Home Farm Lane, flooding properties in the area before flowing into the village. It is also highly likely that College ditch and associated field drains were receiving flood flows from the Old Leach course and Radcot Brook via the Enfield Ditch link.

College Ditch looking east out of village from culvert under road. Note minimal ditch capacity in village

- OCC in conjunction with riparian owners to look at increasing capacity of College Ditch and Manor Farm Ditches through village. (Option C).
- EA investigate excavation of flood attenuation pond upstream of village (Option D)
- EA to investigate effectiveness of offline storage in vicinity of diverted reach (Option I).
- EA to assess operation of overflow pipe reported to be operating from new cut into Old Leach. (Option J).
- EA to investigate operation of sluices at Lechlade Mill and impacts (Option K).

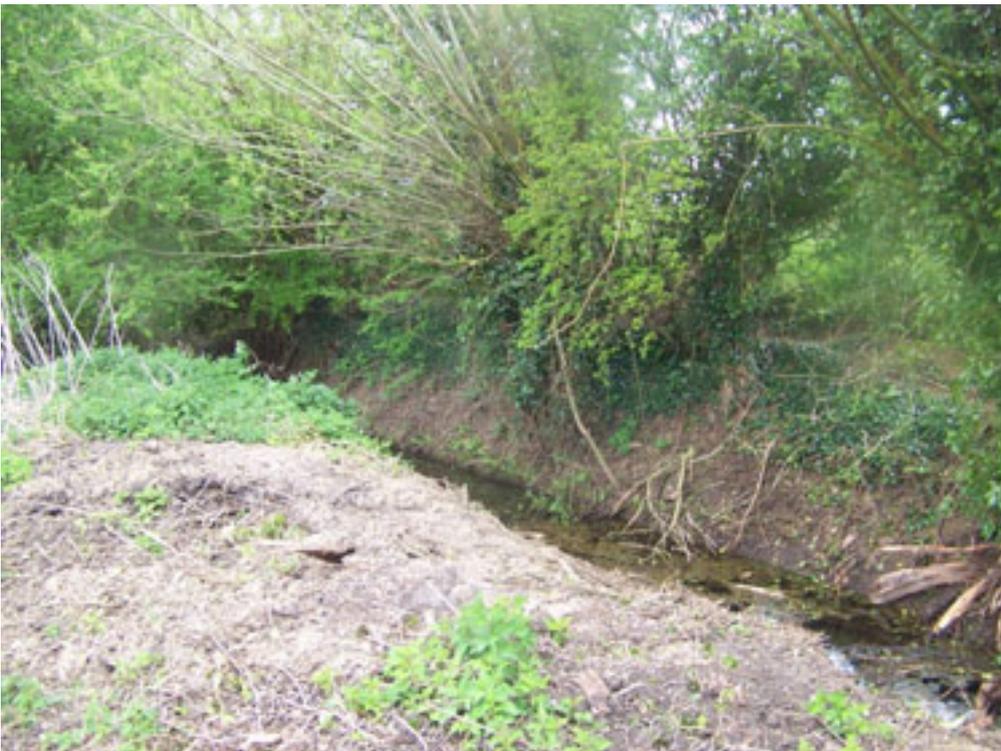
Kelmscott Brook – east of village, looking N at upstream limit of EA maintained section. Village work party channel maintenance clearly shown

- OCC to assist riparian in maintaining roadside ditches through village and riparian owners to manage field drainage (Option B)
- EA to maintain Kelmscott Brook below village – dredge and ensure optimum channel conditions, clear vegetation. Ensure this is done regularly (Option G)

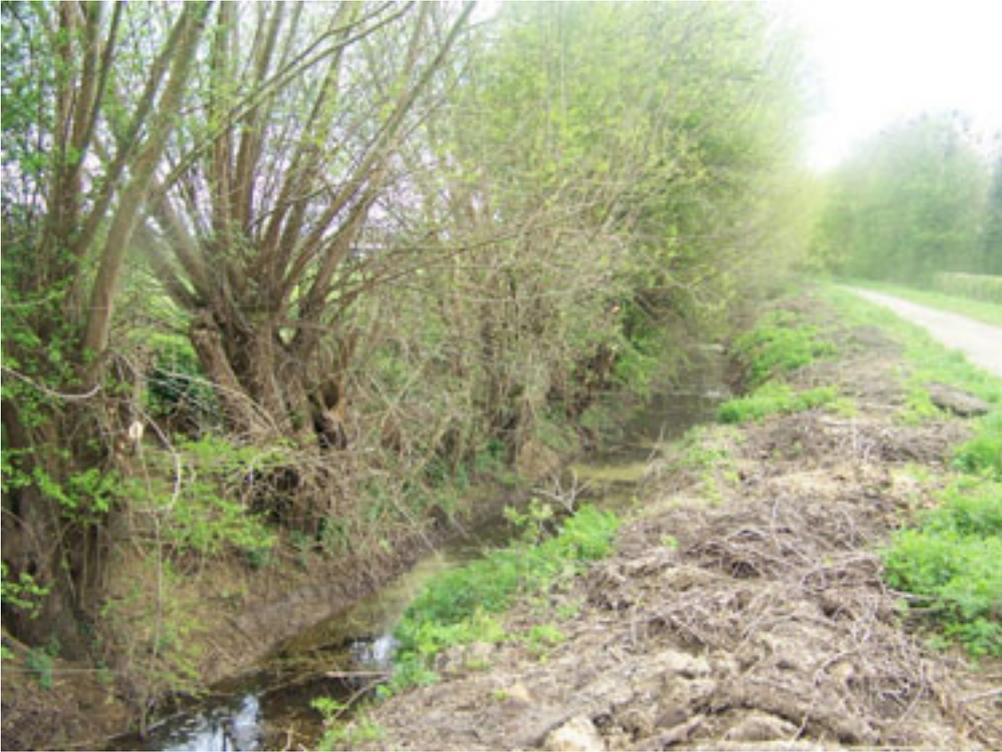
Looking south to Kelmscott down Manor Farm ditch – village work party clearing in evidence. Village work party channel maintenance clearly shown

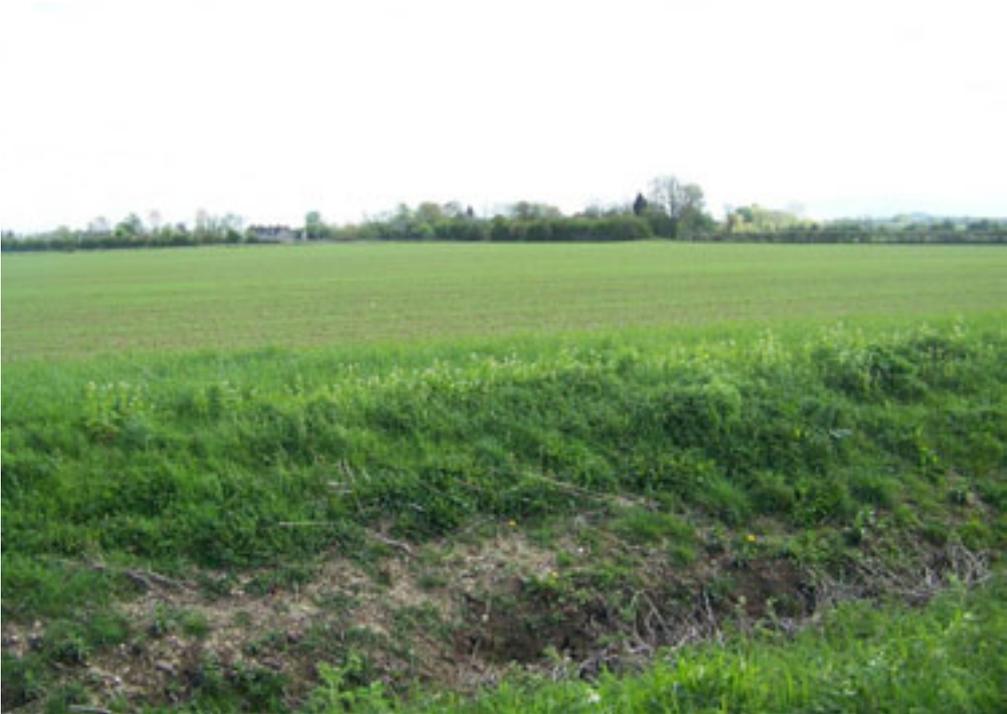
Looking in direction of flood route - east from Enfield Ditch to village

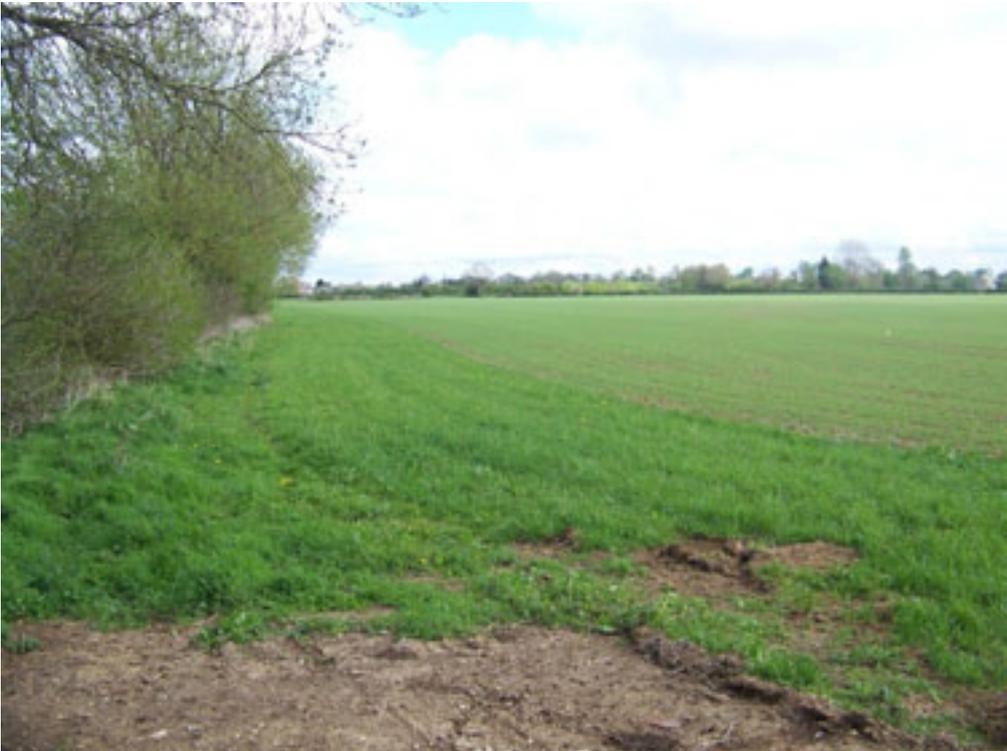
Enfield Ditch / Old Leach looking NE to village

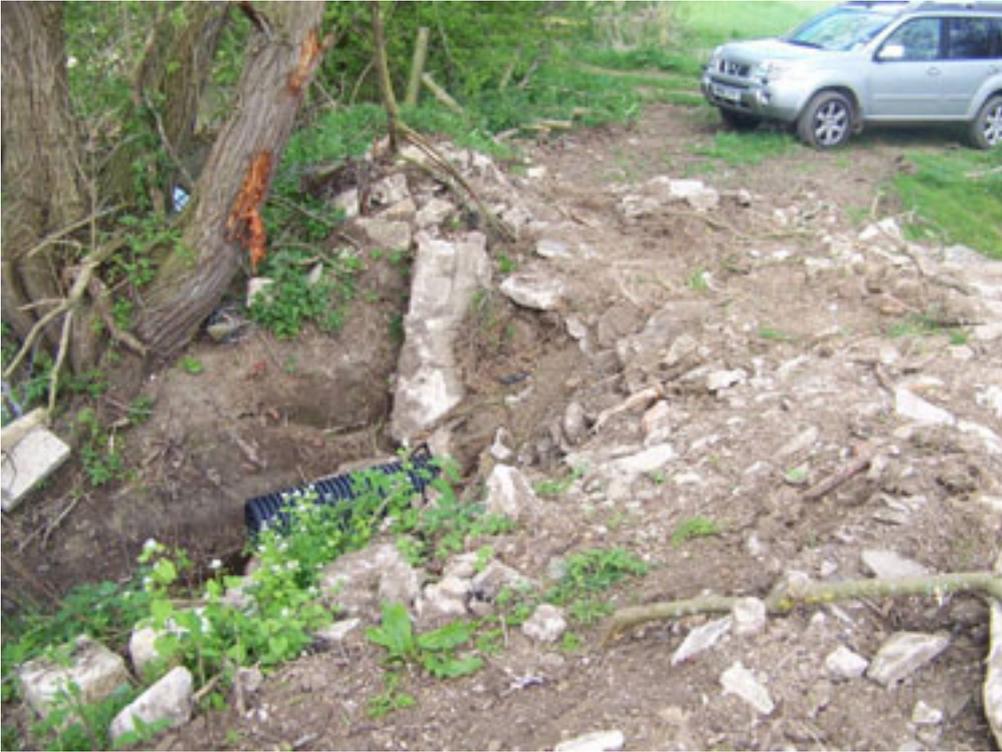
Enfield Ditch – Dammed at confluence with the Old Leach

- Private - prevent flows from entering Enfield / College ditch via blocking off flow route from Radcot Cut (Option A). This has already been done by the work party and will be effective in reducing flooding from Radcot Cut into the drainage network as long as Radcot Cut remains in-bank.
- Private - flood resilient measures to be fitted to individual properties via residents (Option E).
- EA/Private - improve take-up of flood warning service (Option F).
- EA to inspect left bank heights at start of diversionary 'elbow' on River Leach new cut - to assess overtopping into Old Leach (Option H)

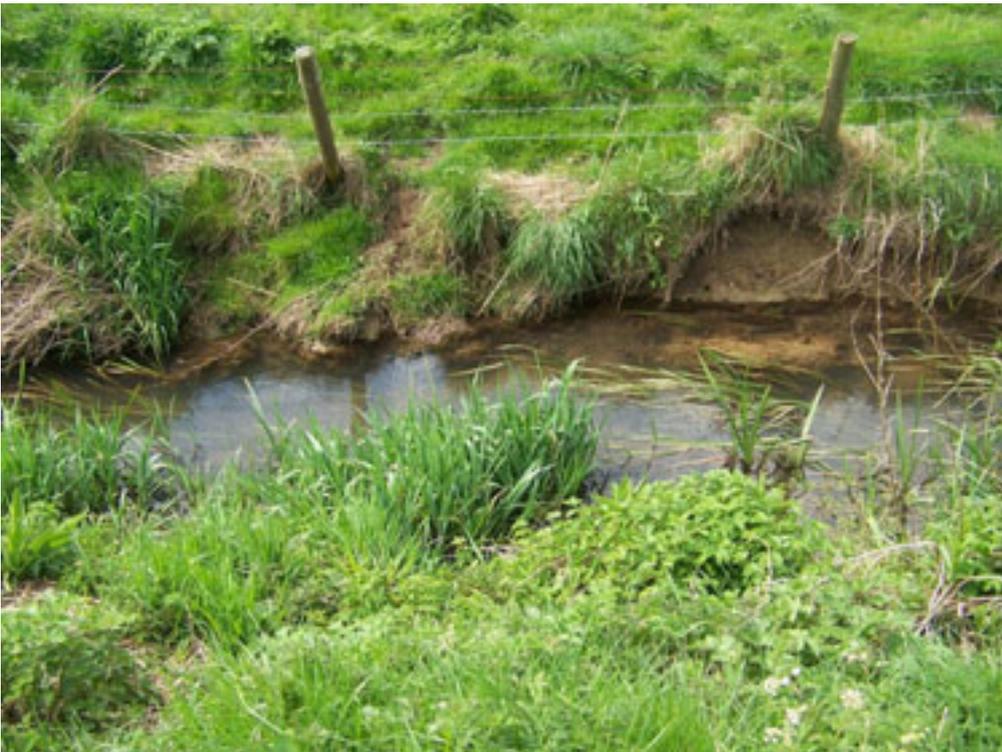
Old River Leach near Enfield Ditch

- EA to maintain channel and banks of Old River Leach (Marlake Ditch) and Radcot Cut (Option C)

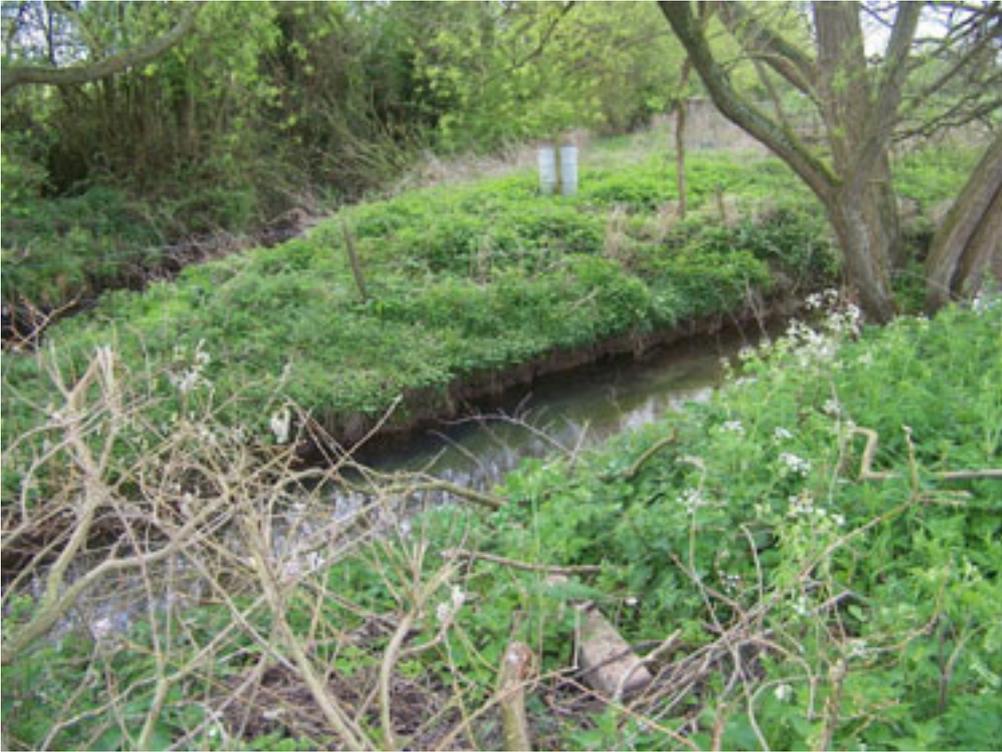
Radcot Cut and Old Leach confluence below village, cleared vegetation in foreground

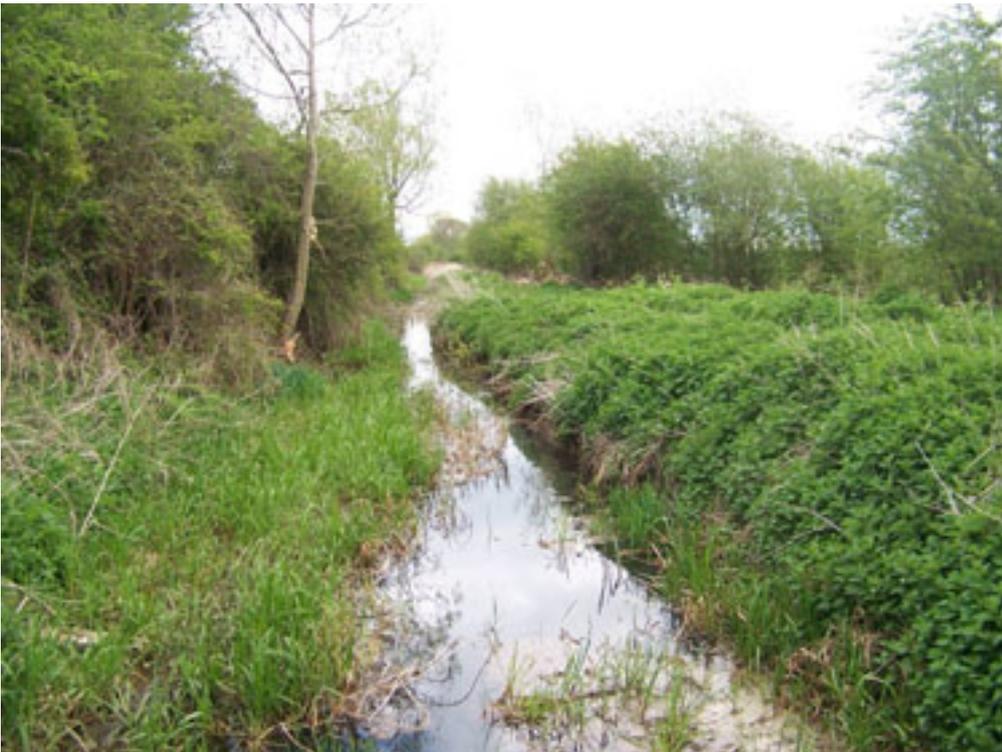
Another source of flow into the Radcot Cut is via overbank flow directly from the River Thames. The Radcot Cut flows south east from Lechlade in a semi-circular route, curving back north-east to Kelmscott village. It then diverts due east below the village and this sudden change in direction is a likely point of overtopping into the village. Levels in the Radcot Cut will have been high due to it being unable to discharge into the high flowing Thames.

Radcot Cut looking west from footbridge. Thames floodplain behind raised bank (RH). Discussion with EA to shore up right bank levels

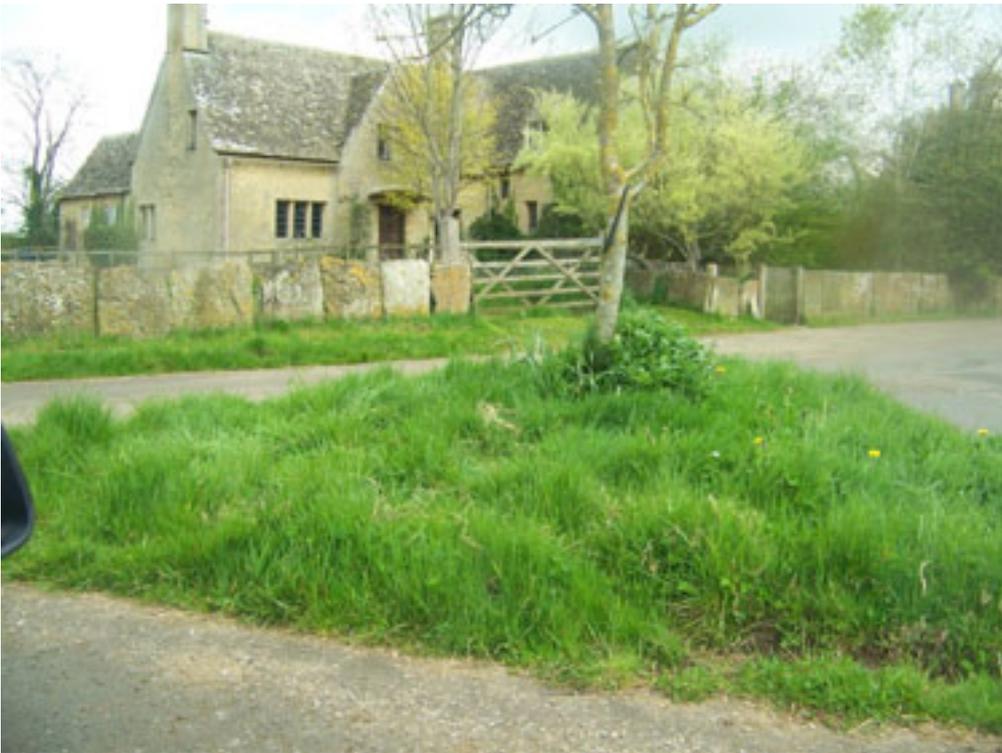
In July 2007, homes in the vicinity of the public house and Kelmscott Manor, were flooded. Water is reported to have been 2-3 feet deep in places.

Triangle adjacent to Manor Farm looking south – floodwaters here reported 2-3ft deep

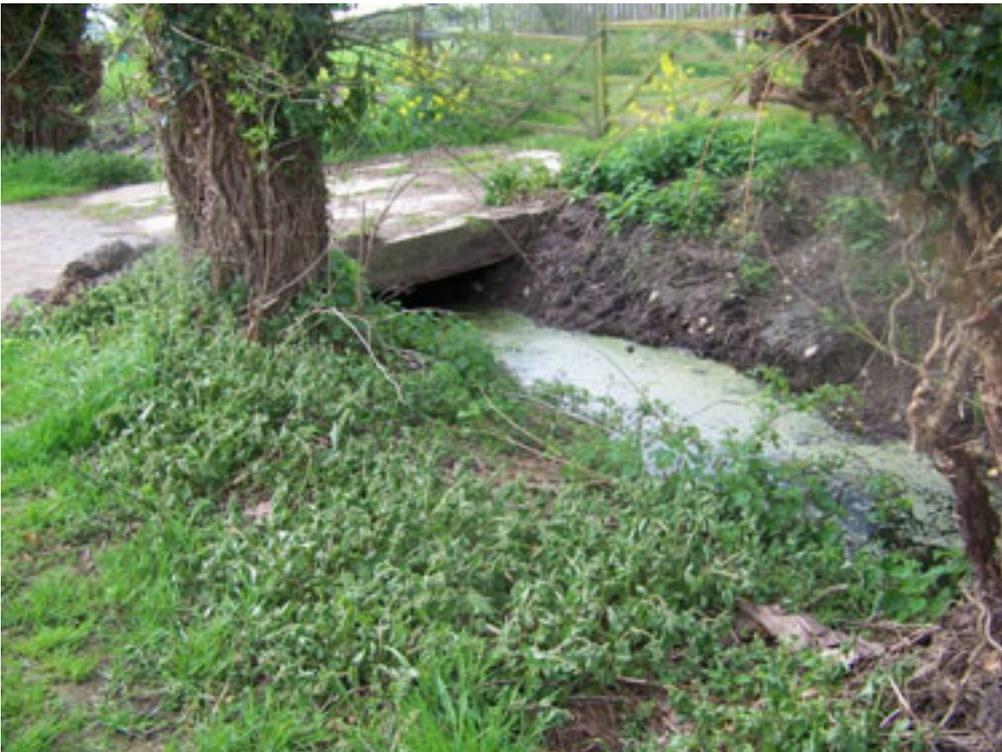
Minimal ditch capacity at Manor Farm – entire section requires deepening, minimal clearance under access bridge
